CASE STUDY

VEHICLE SECTOR: COURIER, DELIVERY

INDUSTRY SECTOR: OFFICE SUPPLY & PRODUCTS

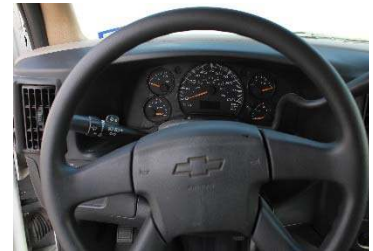
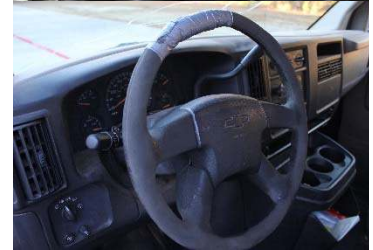
At just over 220,000 miles this van was experiencing low power and transmission slipping.

The front and rear shocks and springs were spent. Front end steering and linkages were well worn and sloppy.

The exterior condition was typical for the mission profile and age except for one side door and one rear door. Other than the doors, there were several dents and dings. The paint was oxidized with a typical number of scratches and patches. The graphics were beginning to fade, roll, crack and peel.

The extensive remanufacturing service replaced not only the power train, but the major assemblies and subassemblies in the list below.

After the original assessment and inconsideration of the unique mission profile of carrying heavy loads of paper, the Leaf Springs were re-arched and supplemented with an additional Leaf Spring. The van now accommodates any paper loading without bottoming out.

Door replacements and Body repair made the new paint job reset the factory appearance and served as an excellent base for new company graphics in the form of a partial vehicle wrap.
